Example Site

All Conveyors

Conveyor Condition Assessment Report

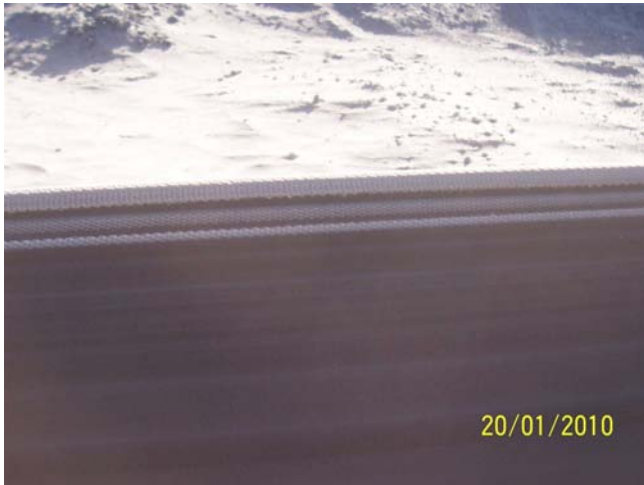
Photo 1 (Excessive edge wear to LHS to carcass.)

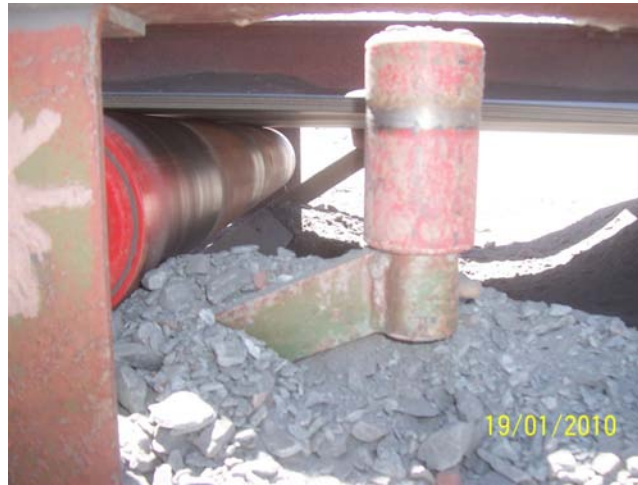
Photo 2 (Tracking frame buried at # 40.)

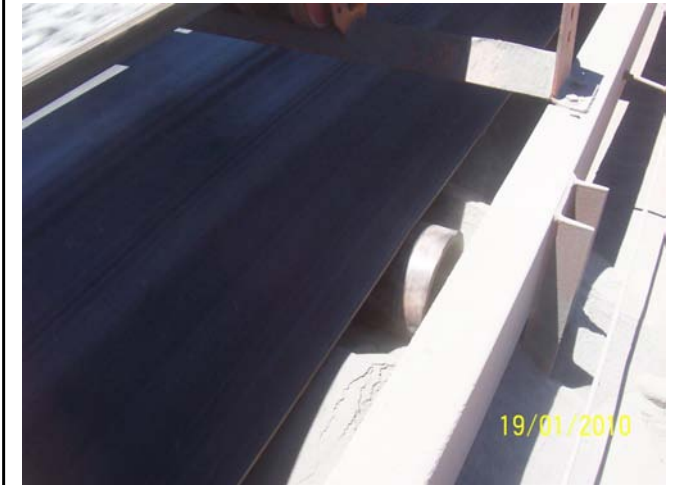
Photo 3 (Excessive material build-up near tru-tracker frame # 142.)

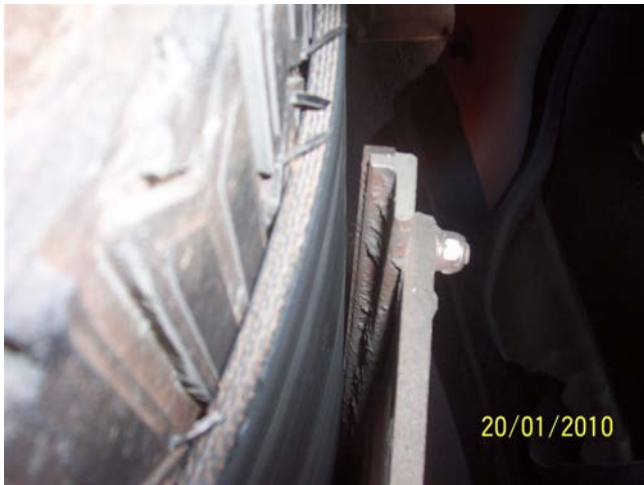
Photo 4 (Primary cleaner requires closer positioning to belt.)

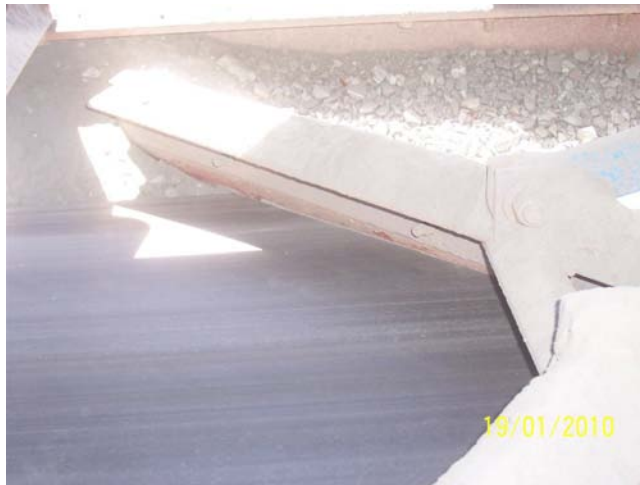
Photo 5 (Excess build-up on LHS/RHS of plough.)

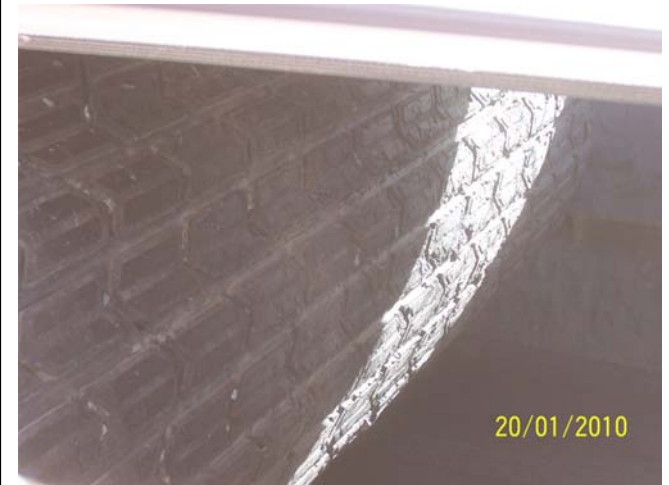
Photo 6 (Cracking and gouges to pulley lagging at center.)

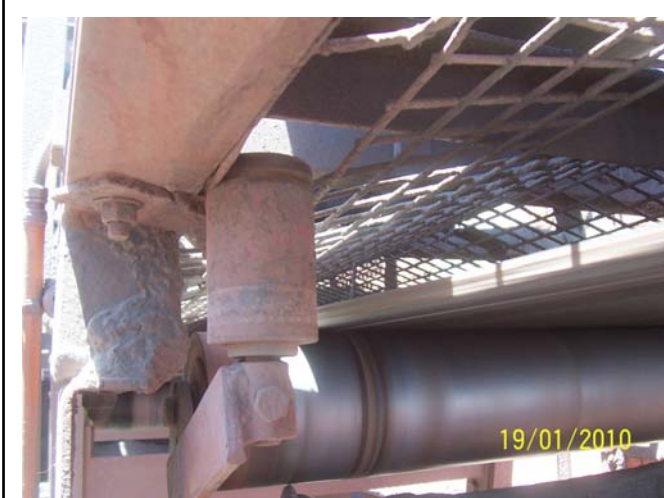
Photo 1 (RHS servo of return tracker hitting structure.)

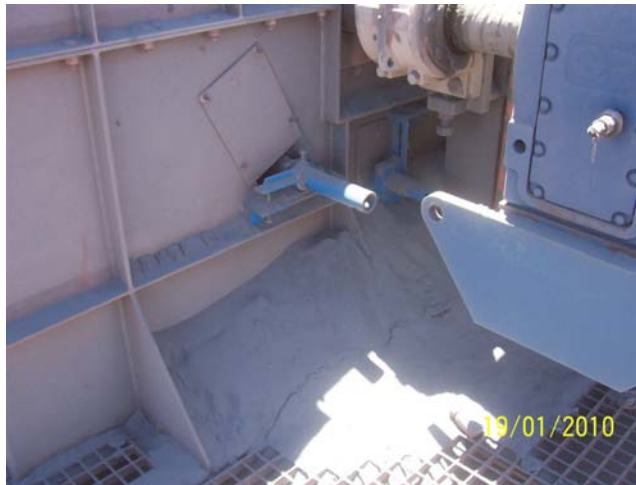
Photo 2 (Signs of material build-up near head end cleaners.)

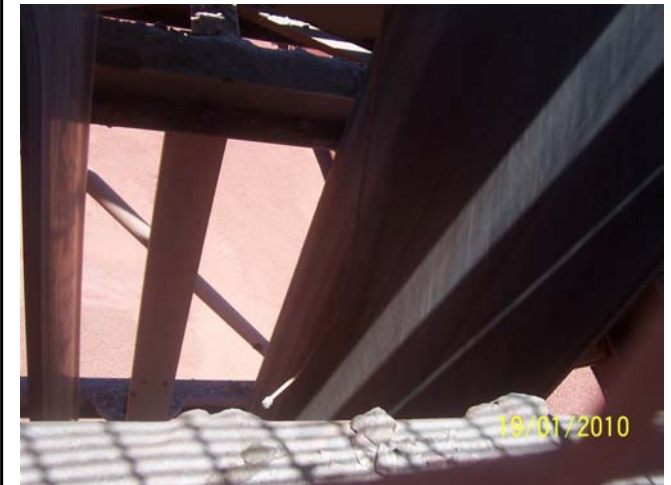
Photo 3 (Lube line limited access head side TUP bend pulley.)

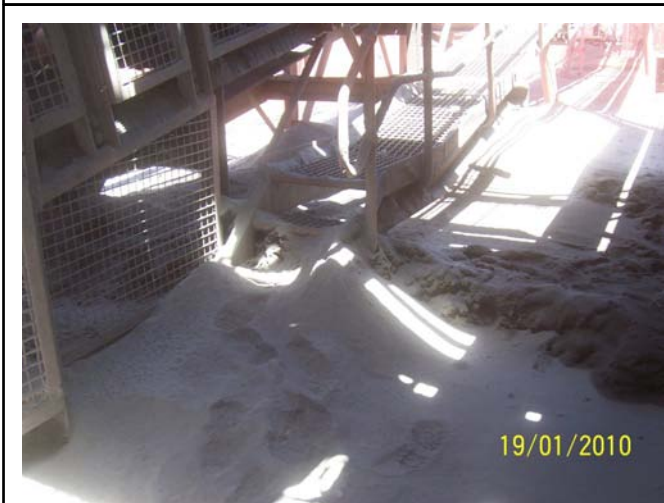
Photo 4 (Excess material build-up at tail end of conveyor.)

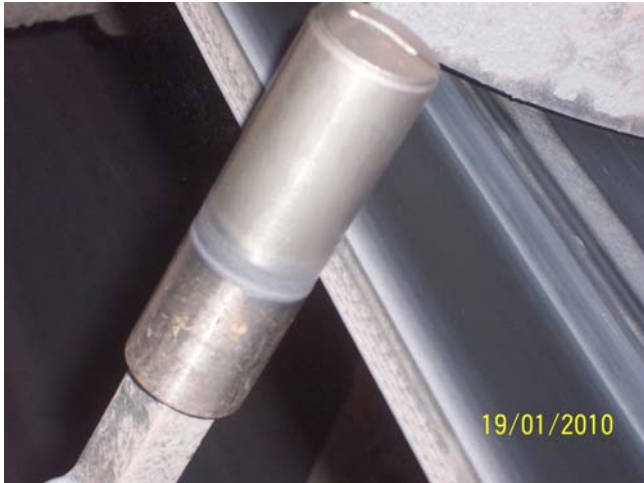
Photo 1 (Signs of wear on LHS tail drift switch.)

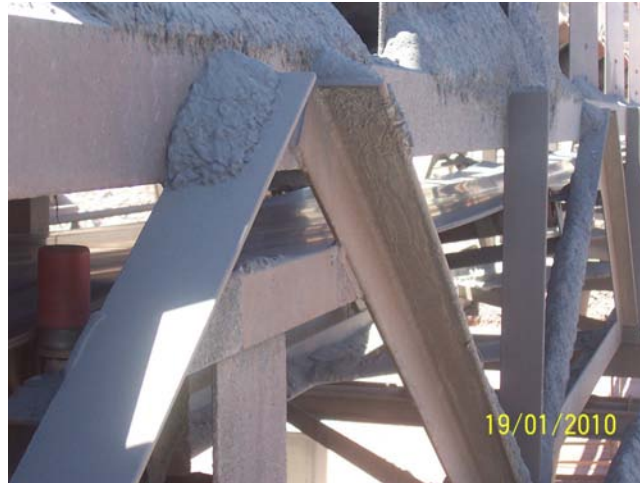
Photo 2 (Signs of insufficient belt tension in system.)

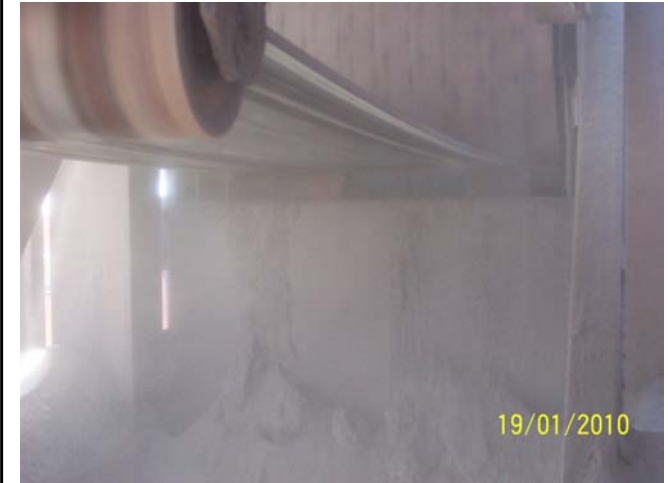
Photo 3 (Excess material build-up under head pulley removed.)

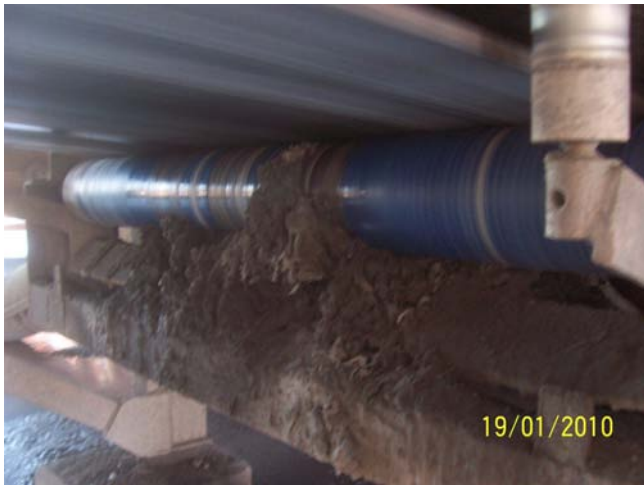
Photo 1 (Frame does not freely rotate and excess material build-up.)

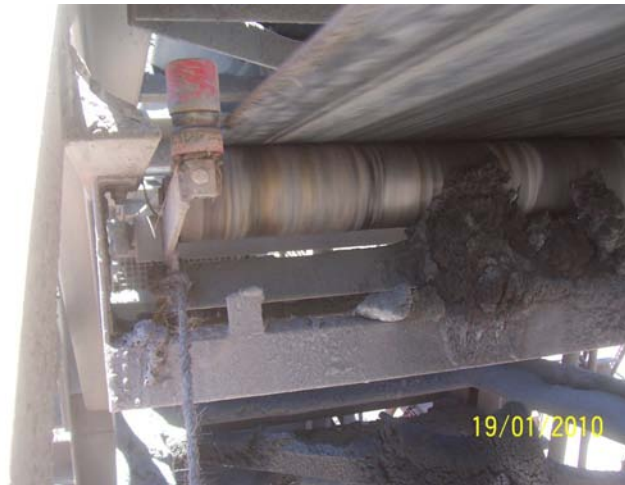
Photo 2 (Frame does not freely rotate and excess material build-up.)

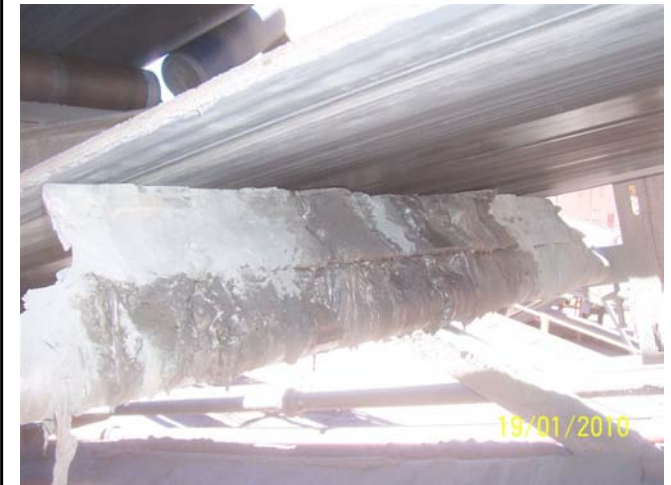
Photo 3 (Excess material build-up on cleaner at frame # 83.)

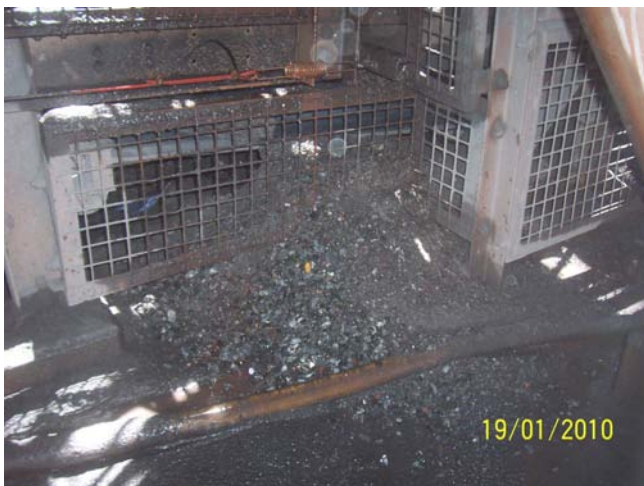
Photo 4 (Excess build-up around LHS/RHS of plough.)

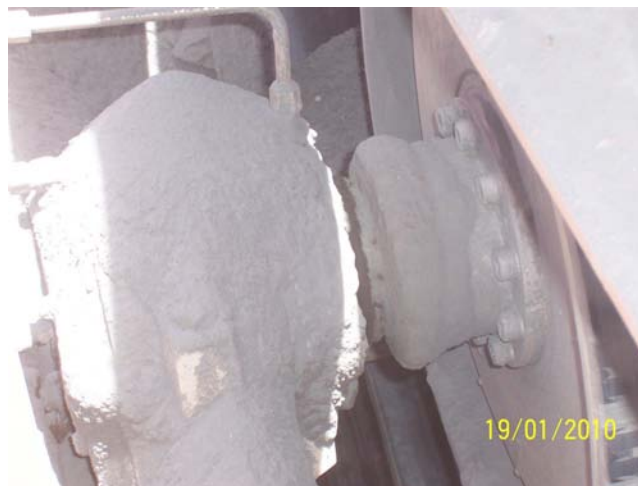
8	Takeup Bend (Rubber - Grooved)	Visual	20-01-10	Fair condition, some material build-up on pulley face. Grease & dust build up on LHS pulley shaft clean/replace.	Fault Minor	(Replace) Clean/replace lagging	
9	Head/Drive (Rubber - Grooved)	Visual	20-01-10	Fair condition	Good

Photo 5 (Grease & dust build up on LHS pulley shaft.)

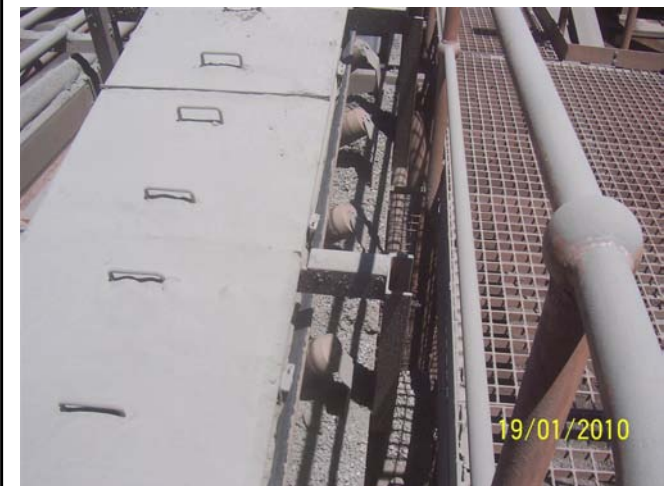
Photo 6 (Excess build-up around trough idlers LHS/RHS @ tripper chute.)

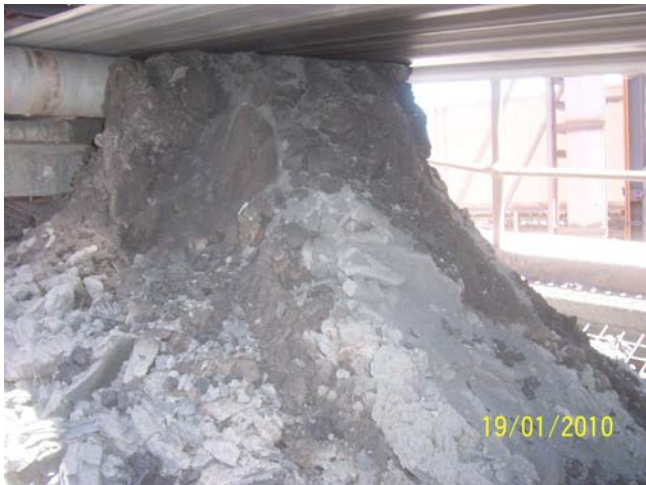
Photo 7 (Excess material build-up around return idlers from Tail onwards.)

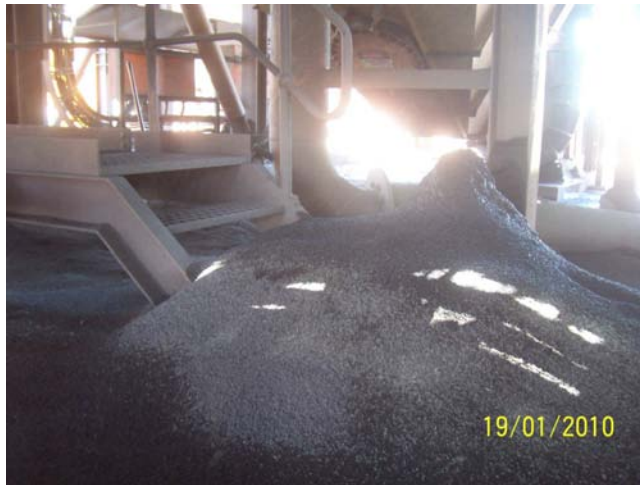
6	General (Material Buildup)	Visual	<u>20-01-10</u>	Excessive material build-up at tail end LHS/RHS walkways require cleaning.	Out of Spec	(Clean/Inspect/Adjust)
7	General (Material Buildup)	Visual	<u>20-01-10</u>	Excess material build-up on frame below # 36, 55, 117.	Out of Spec	(Clean/Inspect/Adjust)

Photo 8 (Excess material build-up at tail end LHS/RHS walkways.)

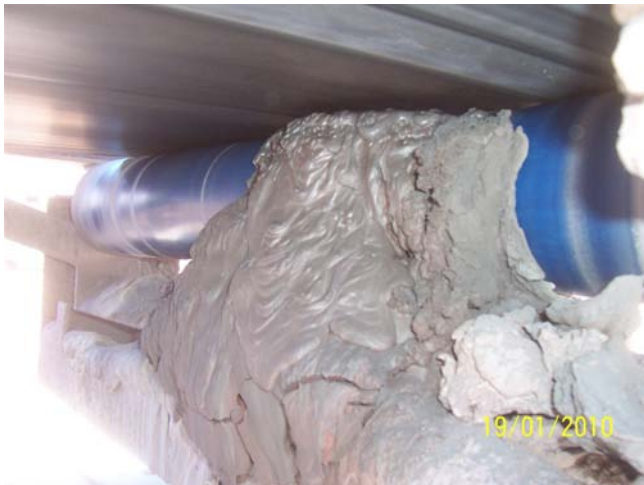
Photo 1 (Excess material build-up around tracking idler.)

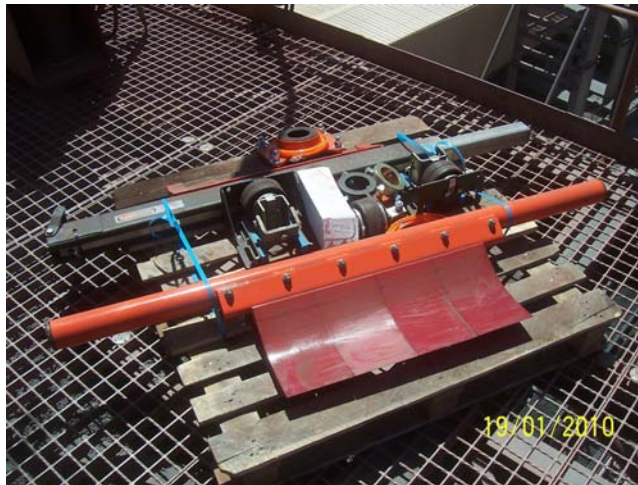
Photo 2 (New cleaners to be installed.)

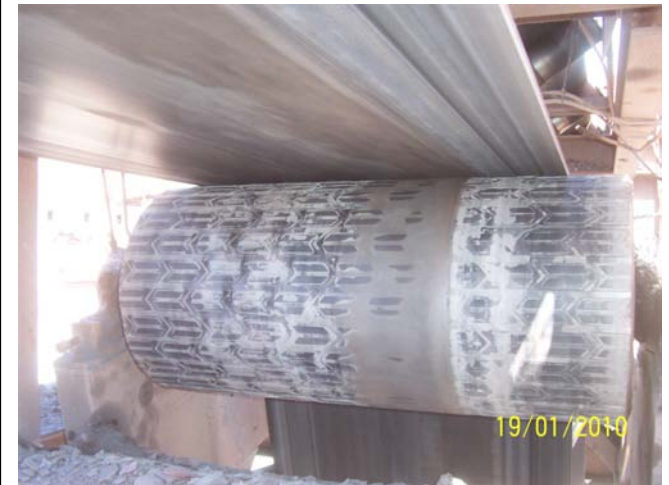
Photo 3 (Material build-up on lagging tread at center.)

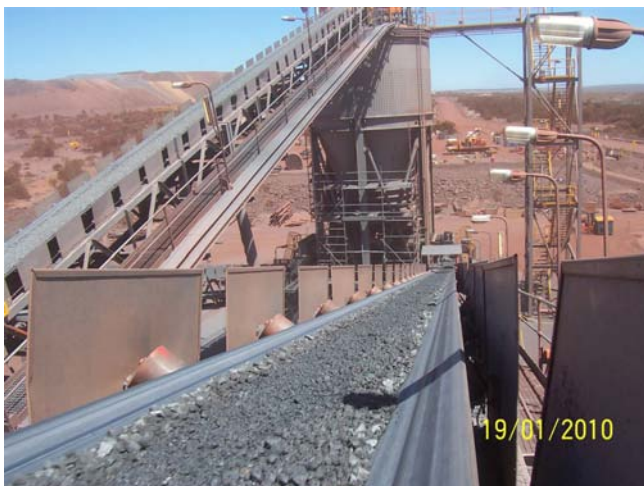
Photo 4 (Belt tracking to the LHS.)

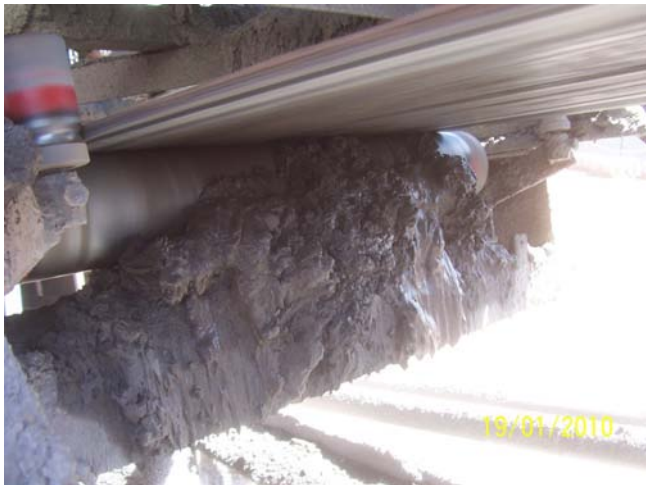
Photo 1 (Excess material build-up around return idler.)

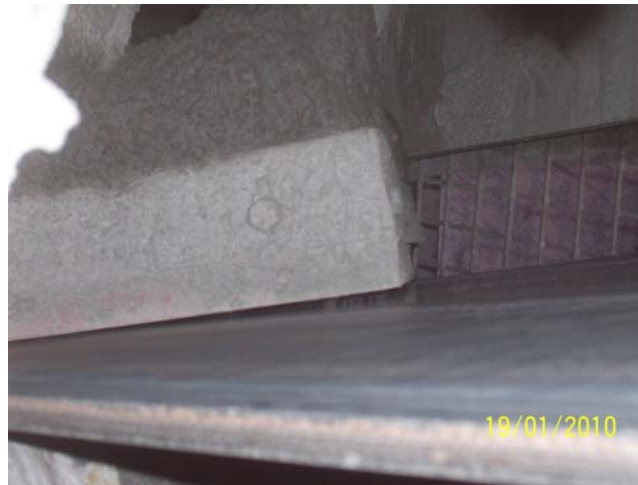
Photo 2 (Plough at tail build-up on blade and poor nose contact.)

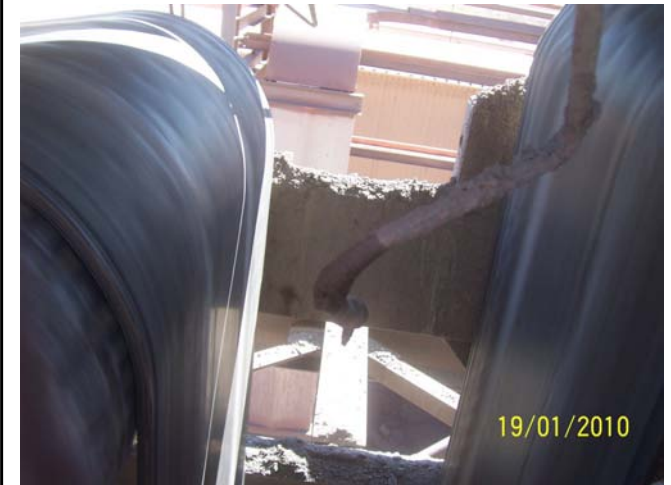
Photo 3 (Lube line bent and not connected at TS TUP pulley.)

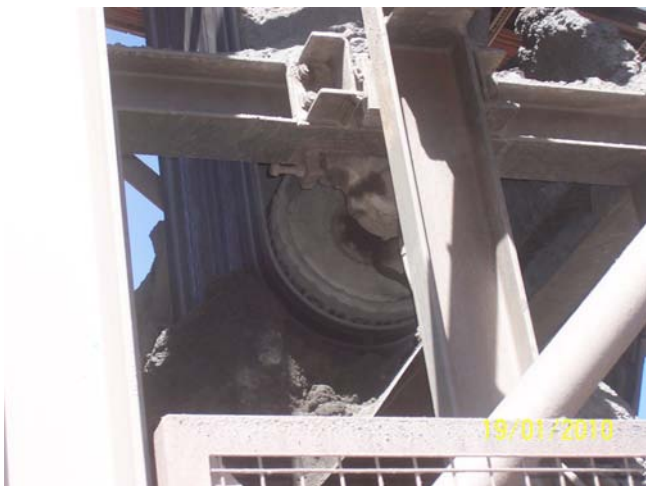
Photo 4 (Material build-up around TUP pulley.)

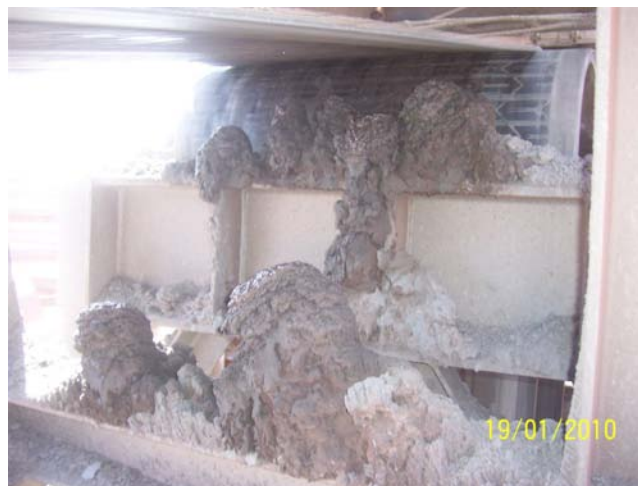
Photo 5 (Excess material build-up on frame near TS TUP.)

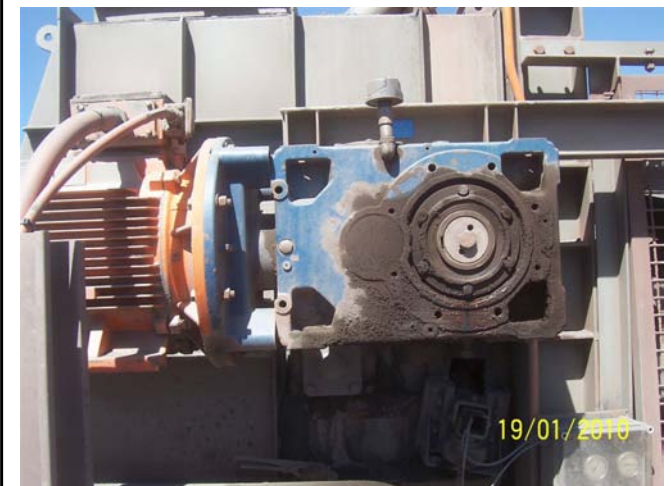
Photo 6 (No cover to open ended shaft of motor gearbox.)

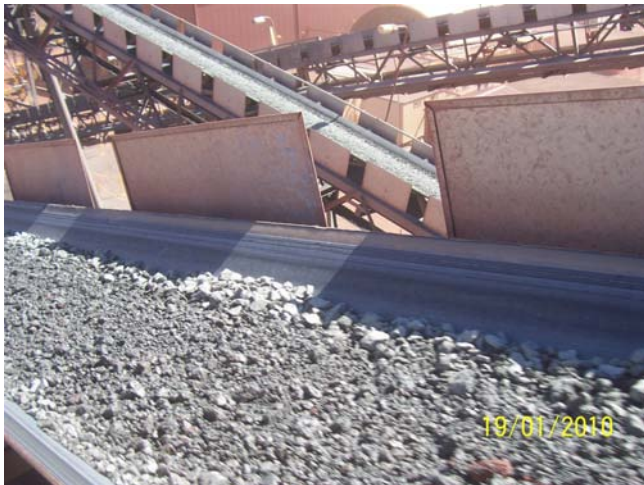
Photo 1 (Section 3m long on LHS edge torn back to carcass.)

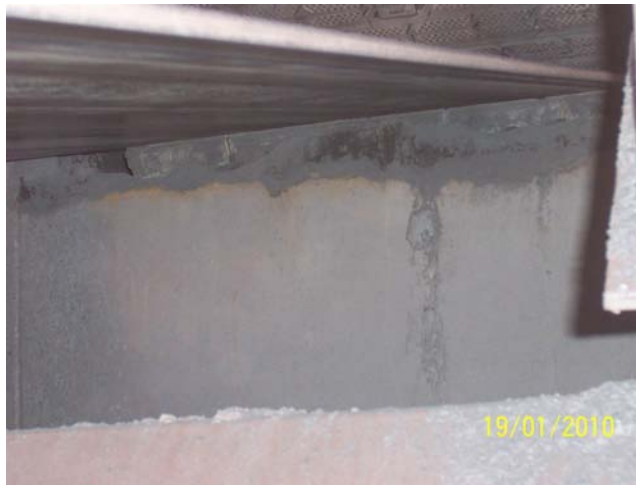
Photo 2 (Material build-up on frame near pulley.)

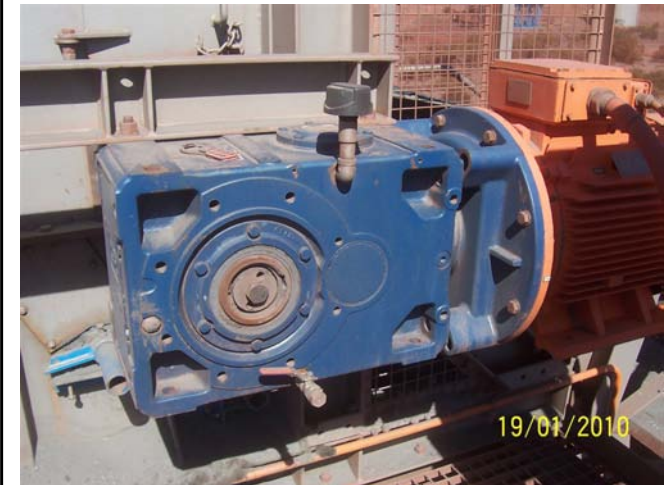
Photo 3 (No cover to open ended shaft of motor gearbox.)

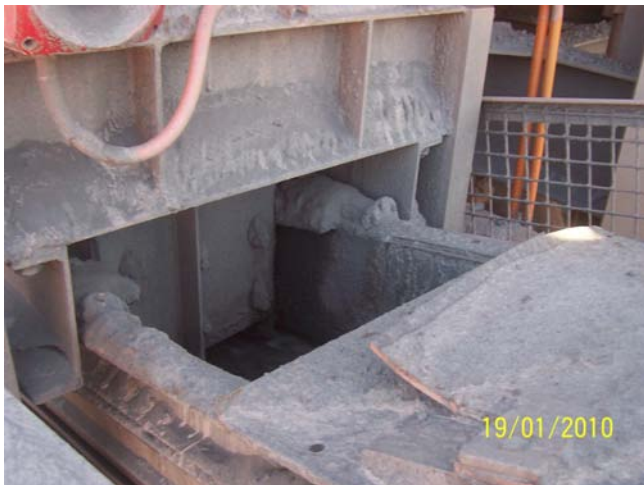
Photo 4 (Chute cover at tail end transfer requires readjusting.)

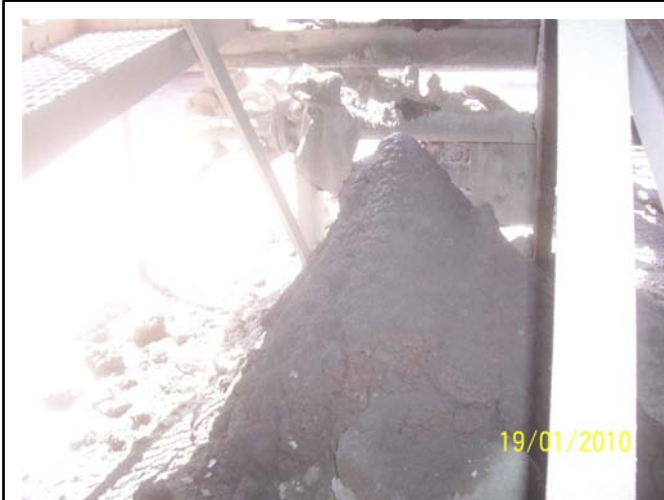
Photo 1 (Excess material build-up at tail end.)

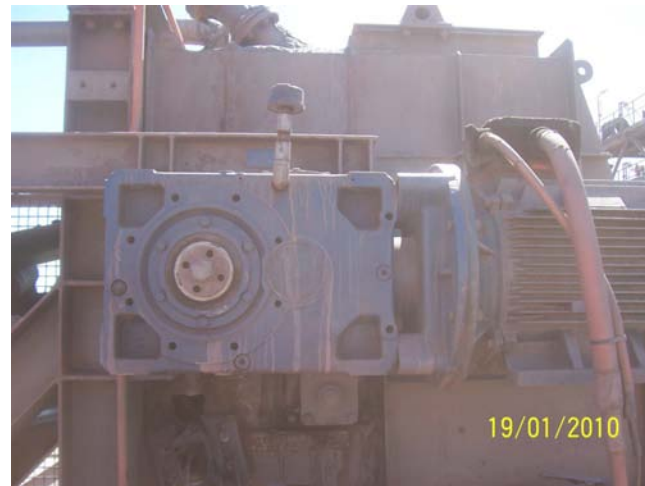
Photo 2 (No cover to open ended shaft of motor gearbox.)
