Example Site

All Conveyors

Conveyor Condition Assessment Report

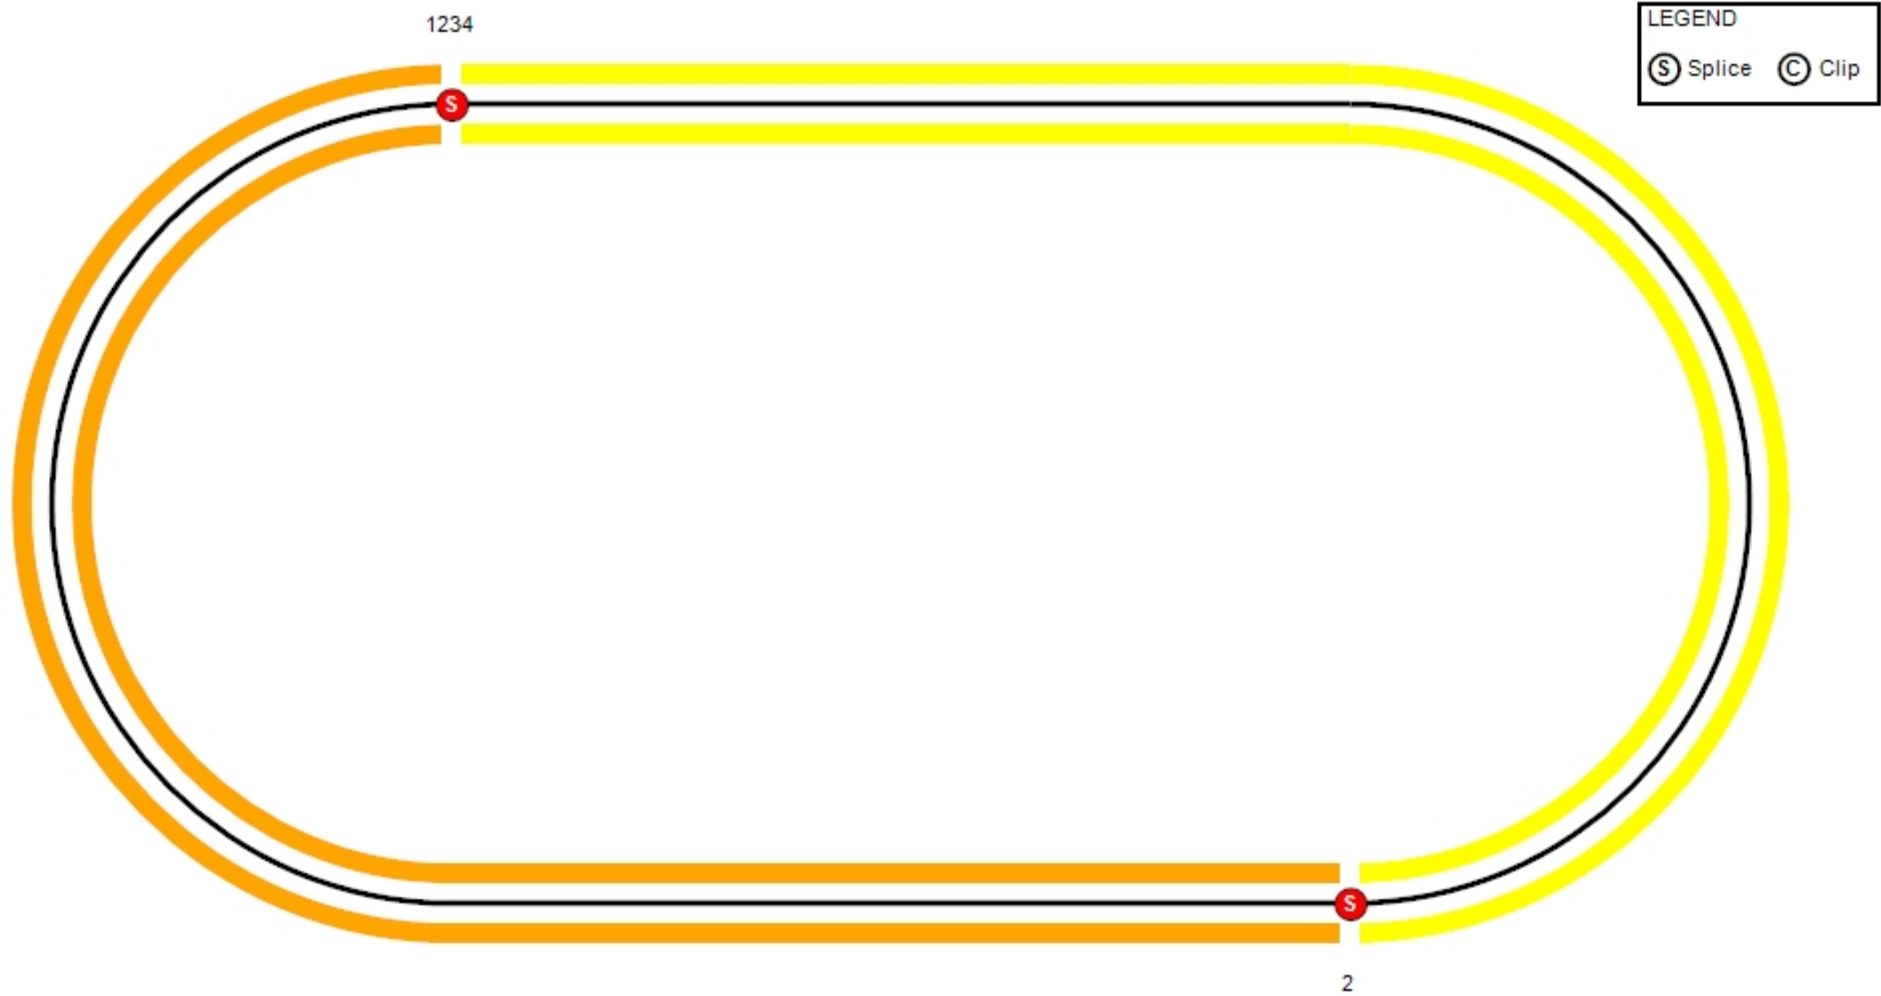
CC010 Conveyor

Conveyor Belt										
#	Joint Detail	Test Date	Comment / Action	Condition	#	Belt Detail	Test Date	Comment / Action	Condition TC	Condition BC
1	Splice	20-01-10	Top cover: Poor condition, LHS splice patch repair with evidence of further deterioration. Bottom cover: Poor condition, wear and delaminating at edge to carcass. (Clean/Inspect/Adjust) Plan for belt replacement or splice repair.	Major Fault	1	PN800/4 750 6+2 Goodyear Roll: 2979A1 Install: 31-03-10	20-01-10	Top Cover: Poor condition, continued LHS edge wear to carcass 3-5cm from edge across belt length. (refer photo) (Clean/Inspect/Adjust) Monitor for further degradation. Bottom Cover: Fair condition, edge cracking/wear on LHS/RHS. (Clean/Inspect/Adjust) Monitor for further degradation.	Fault Minor	Fault Minor
2	Splice	20-01-10	Top cover: Poor condition, worn to the carcass on RHS/LHS edge. Bottom cover: Poor condition (Clean/Inspect/Adjust) Plan for belt replacement or splice repair.	Major Fault	2	IMAS Roll: F9053B Install: 31-03-10	20-01-10	Top Cover: Poor condition, continued LHS edge wear to carcass 3-5cm from edge across length of belt. (Clean/Inspect/Adjust) Monitor for further deterioration. Bottom Cover: Fair condition, edge cracking/wear on LHS/RHS. (Clean/Inspect/Adjust) Monitor for further deterioration.	Out of Spec	Out of Spec

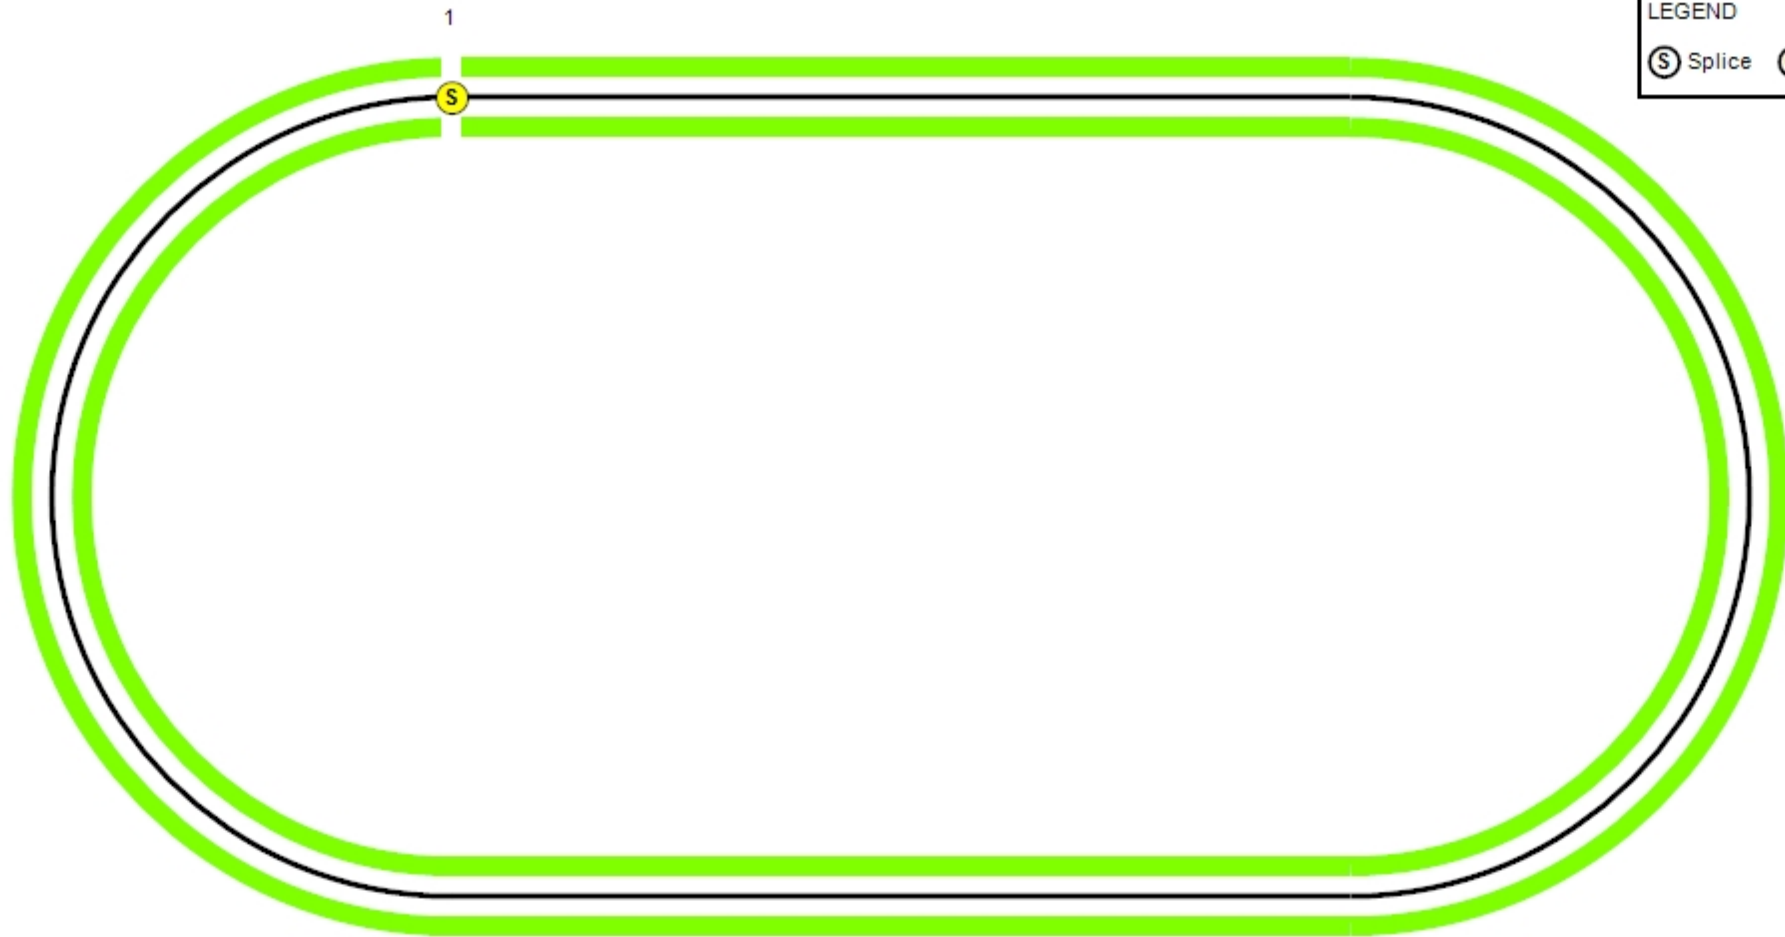
CC001 Conveyor - Belting Details

Conveyor Belt										
#	Joint Detail	Test Date	Comment / Action	Condition	#	Belt Detail	Test Date	Comment / Action	Condition TC	Condition BC
1	Splice	20-01-10	Top Cover: Fair condition, delaminating on top LHS cover of splice monitor for further degradation. Bottom Cover: Fair condition (Clean/Inspect/Adjust)	Fault Minor	1	IMAS Install: 31-03-10	20-01-10	Top Cover: Fair condition, LHS edge frayed and worn to carcass in parts. (Clean/Inspect/Adjust) Monitor for further degradation. Bottom Cover: Good condition (Clean/Inspect/Adjust)	Good	Good

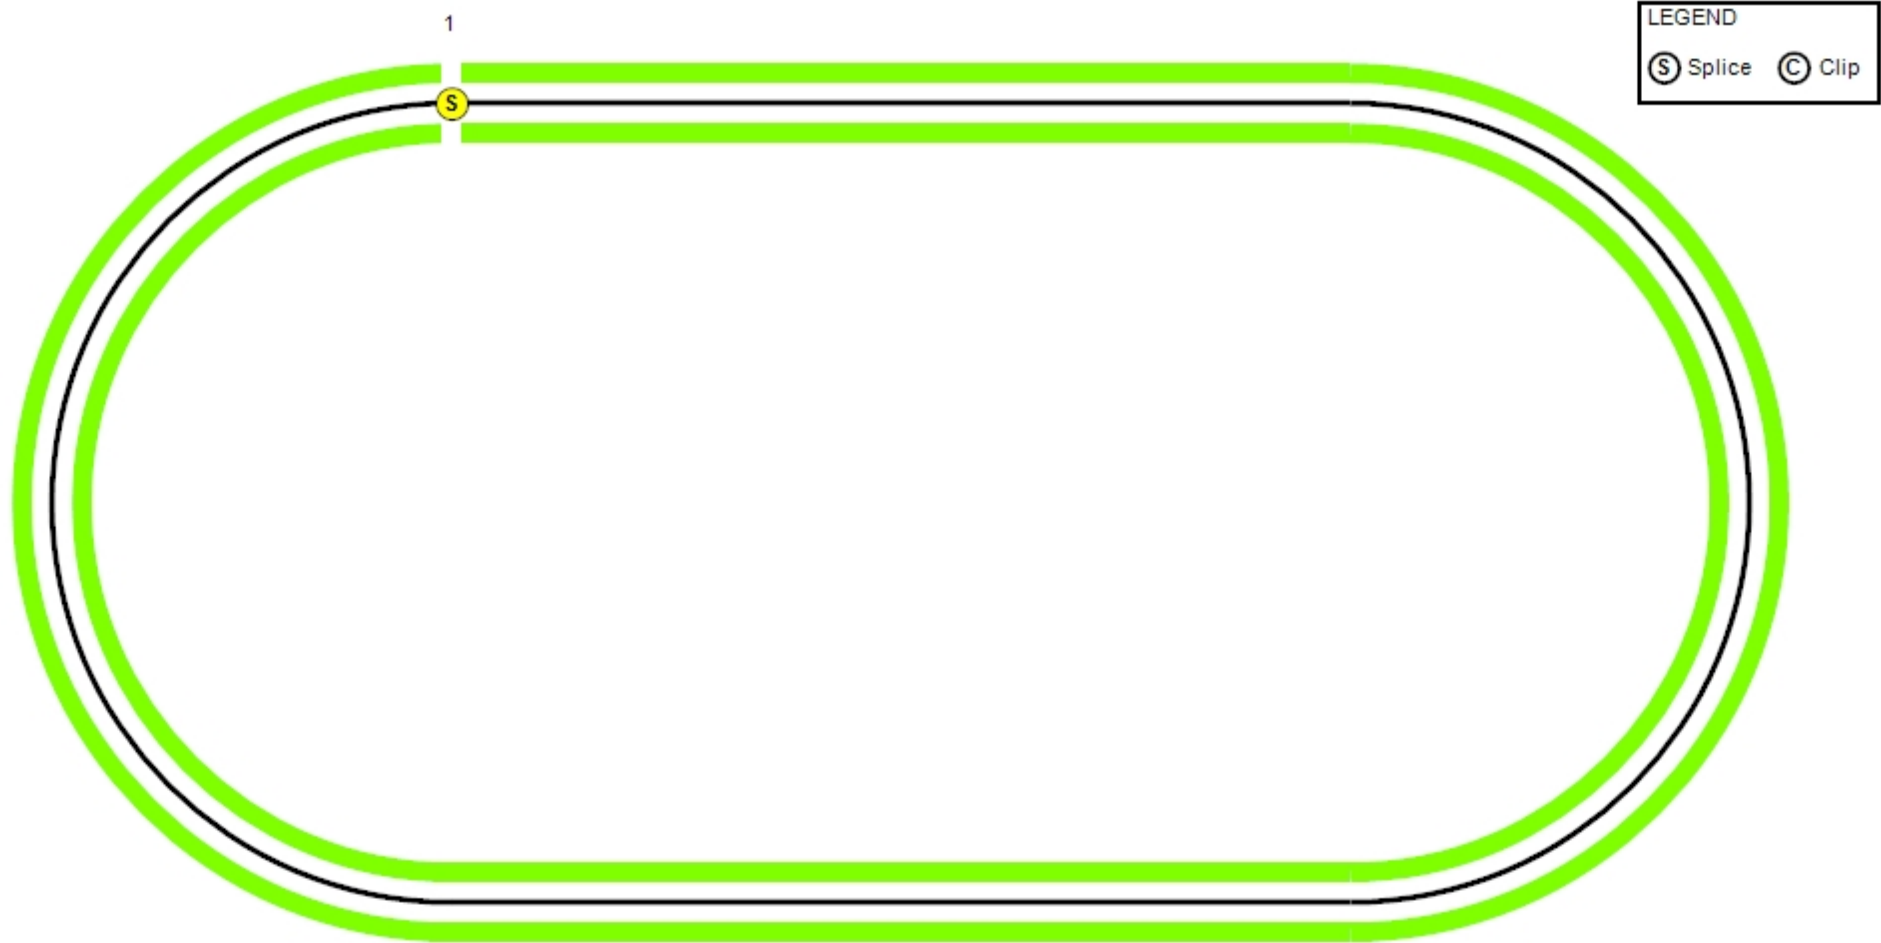
CC002 Conveyor

Conveyor Belt										
#	Joint Detail	Test Date	Comment / Action	Condition	#	Belt Detail	Test Date	Comment / Action	Condition TC	Condition BC
1	Splice	20-01-10	Top cover: Fair condition, delaminating at LHS 10cm from edge. Bottom cover: Fair condition	Fault Minor	1	IMAS Install: 31-03-10	20-01-10	Top Cover: Fair condition Bottom Cover: Fair condition	Good	Good

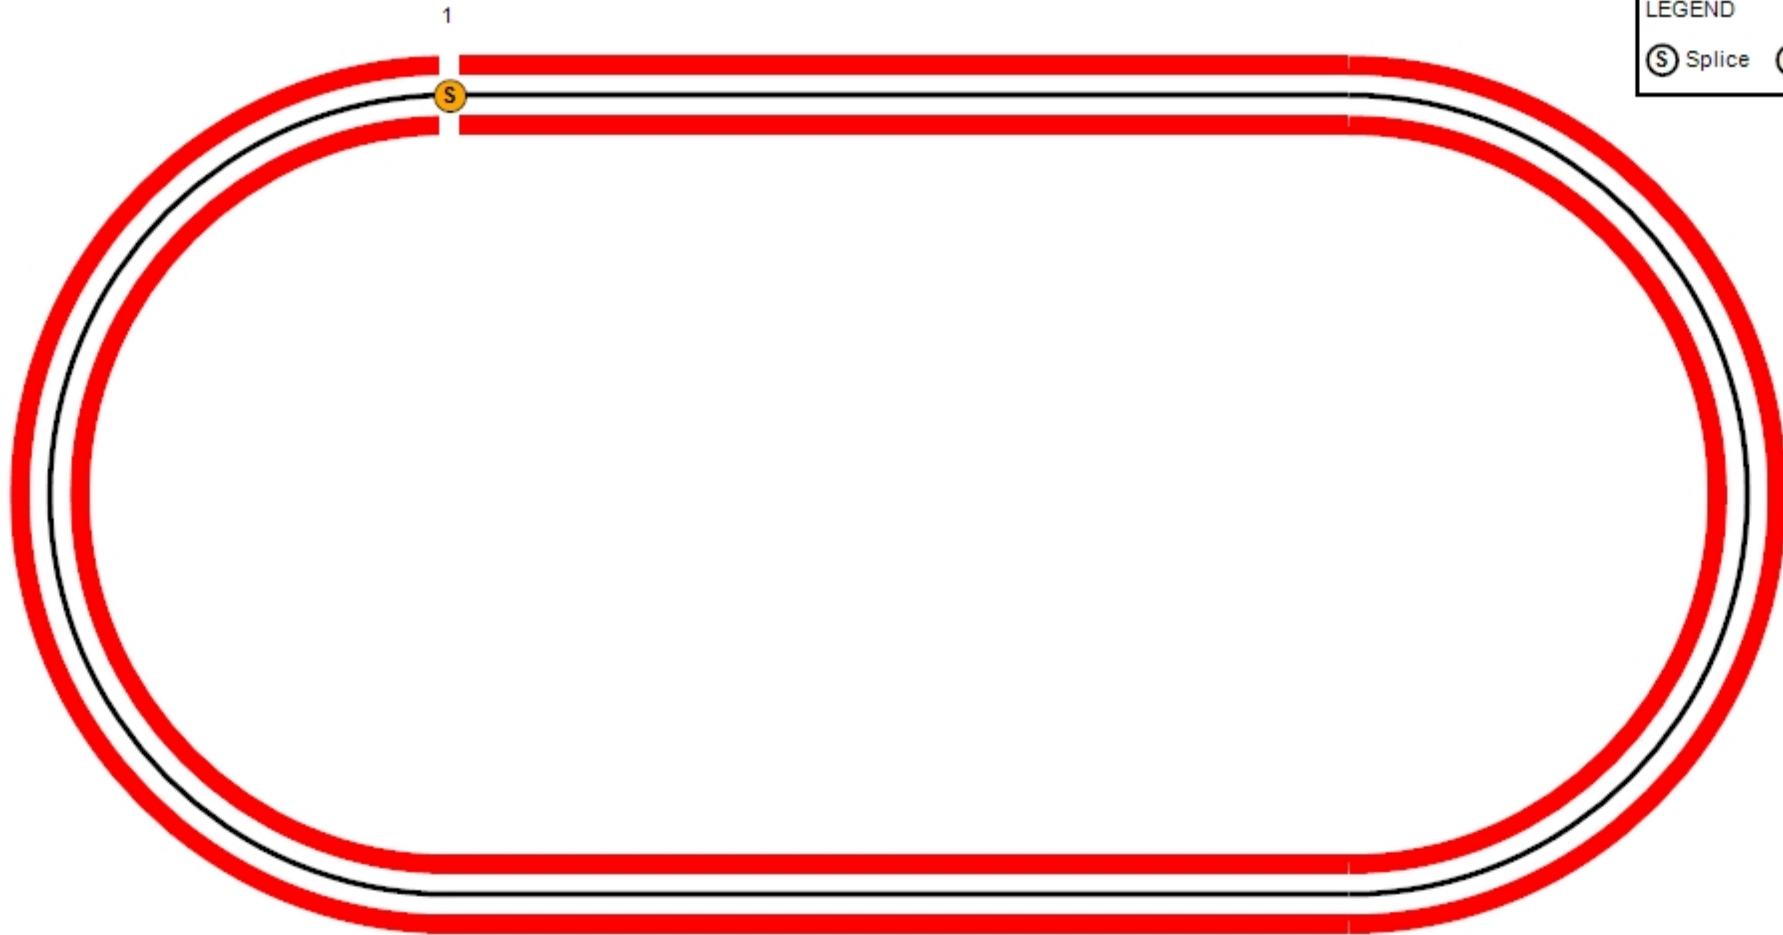
CC003 Conveyor - Belting Details

Conveyor Belt										
#	Joint Detail	Test Date	Comment / Action	Condition	#	Belt Detail	Test Date	Comment / Action	Condition TC	Condition BC
1	Splice	20-01-10	Bottom cover: Fair condition. Top cover: Poor condition, delaminating on RHS top edge at 1st ply. (Belting - Replace)	Out of Spec	1	Install: 31-03-10	20-01-10	Top Cover: Poor condition, worn to the carcass length of belt 3cm from edge RHS. Belt generally very thin from ultrasonic measurements. Severe edge wear and fraying. (Belting - Replace) Prepare for belt change. Bottom Cover: Poor condition (Belting - Replace)	Major Fault	Major Fault

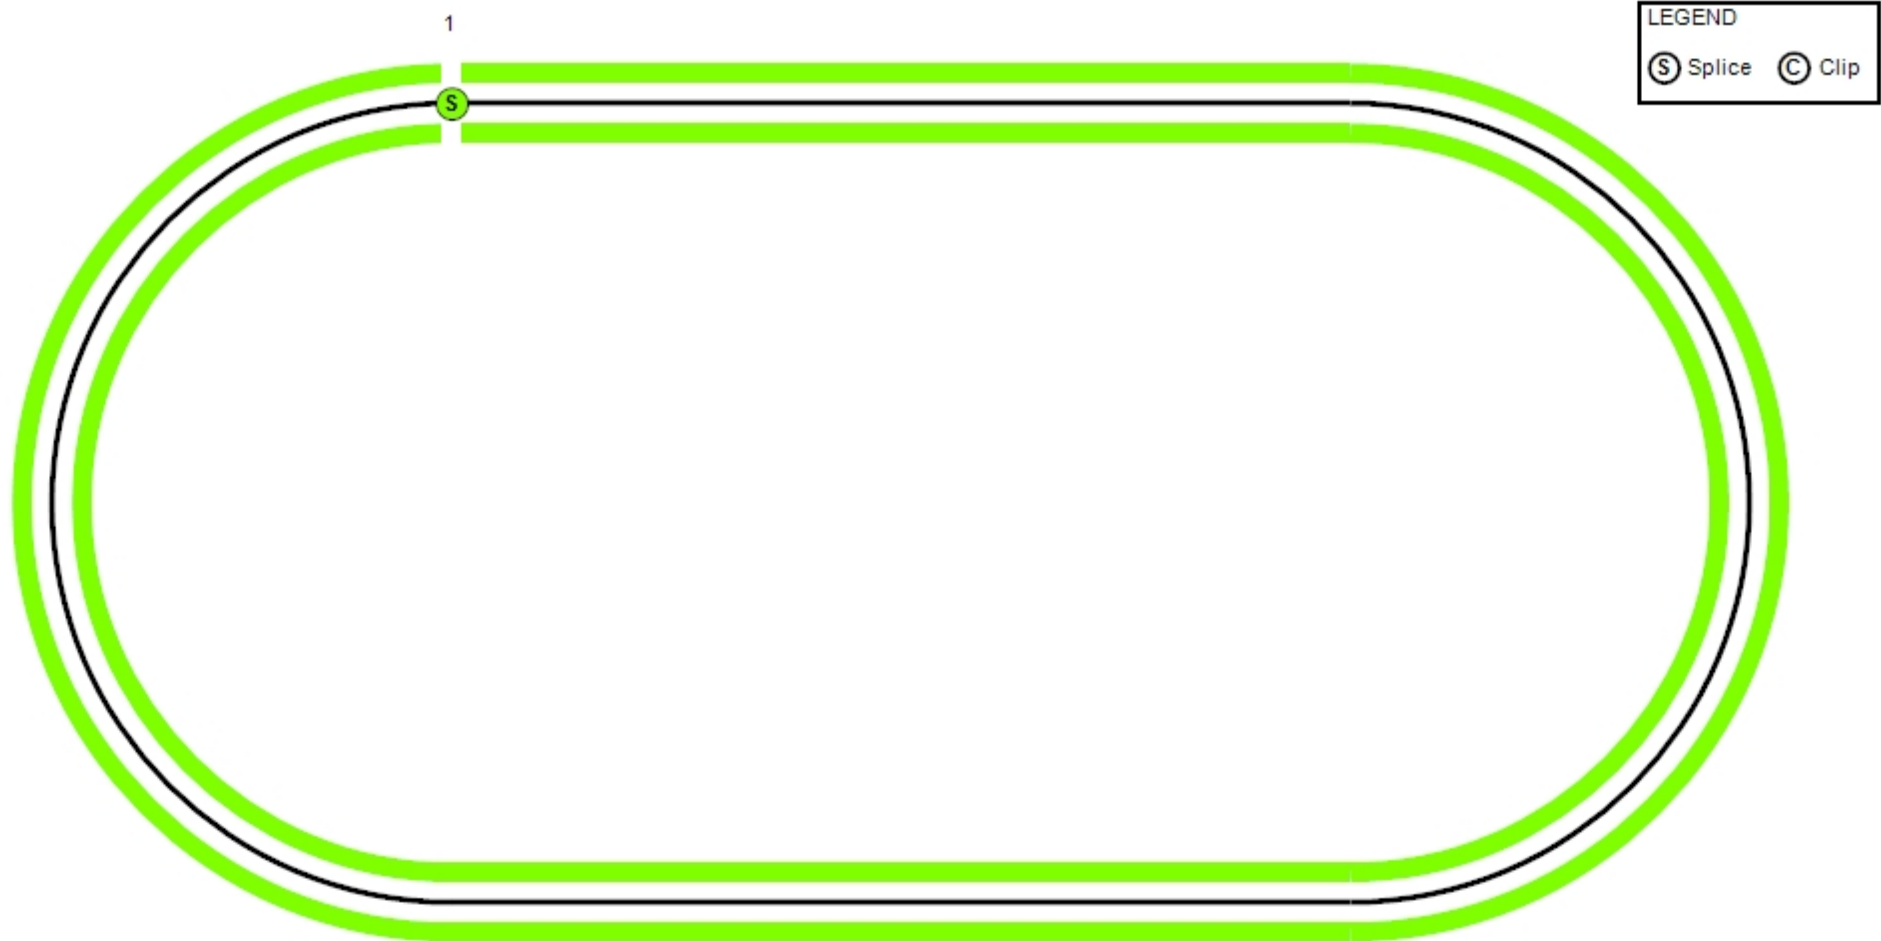
CC104 Conveyor

Conveyor Belt										
#	Joint Detail	Test Date	Comment / Action	Condition	#	Belt Detail	Test Date	Comment / Action	Condition TC	Condition BC
1	Splice	02-01-10	Good condition	Good	1	IMAS Install: 31-03-10	20-01-10	Top Cover: Good condition, evidence of skirt-line wear on LHS. Bottom Cover: Good condition	Good	Good

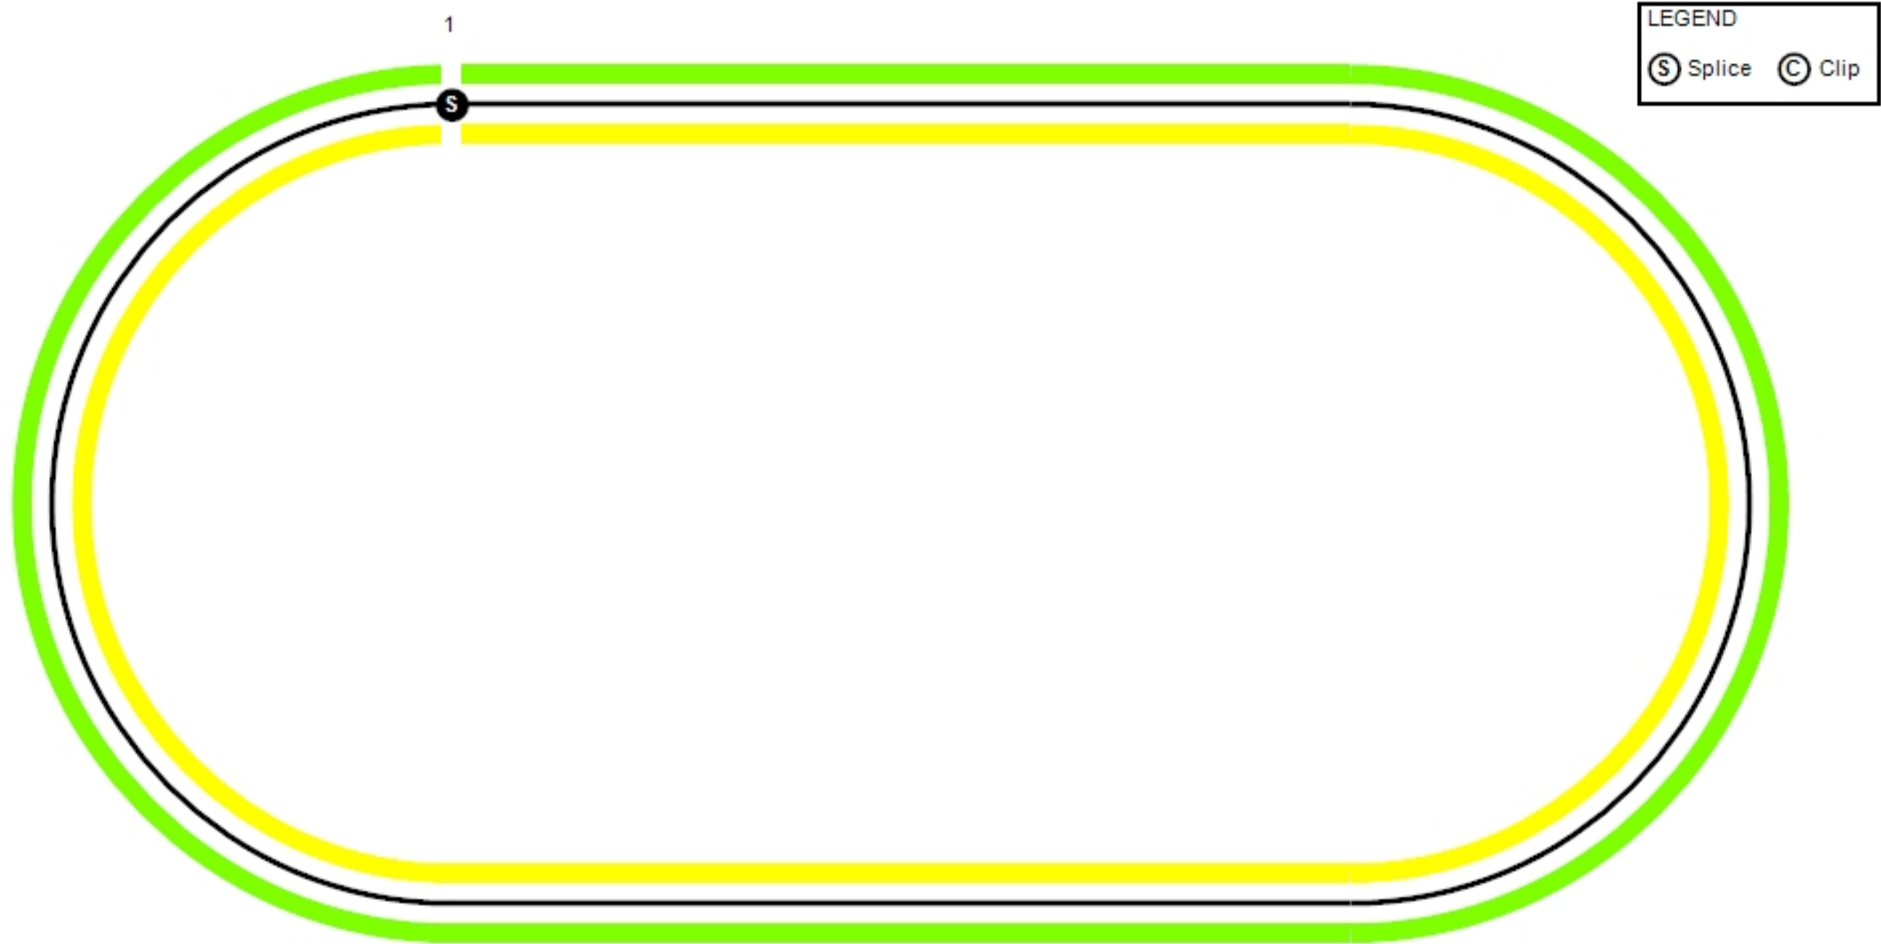
CC105 Conveyor

Conveyor Belt										
#	Joint Detail	Test Date	Comment / Action	Condition	#	Belt Detail	Test Date	Comment / Action	Condition TC	Condition BC
1	Splice	20-01-10	Top cover: Fair condition Bottom cover: Poor condition, splice torn away from join and flapping against passing idler. (Clean/Inspect/Adjust) Repair immediately.	STOP FIX	1	IMAS Roll: 3800A1 Install: 31-03-10	20-01-10	Top Cover: Good condition (Clean/Inspect/Adjust) Bottom Cover: Fair condition, some edge damage RHS. (Clean/Inspect/Adjust) Monitor closely for further degradation.	Good	Fault Minor

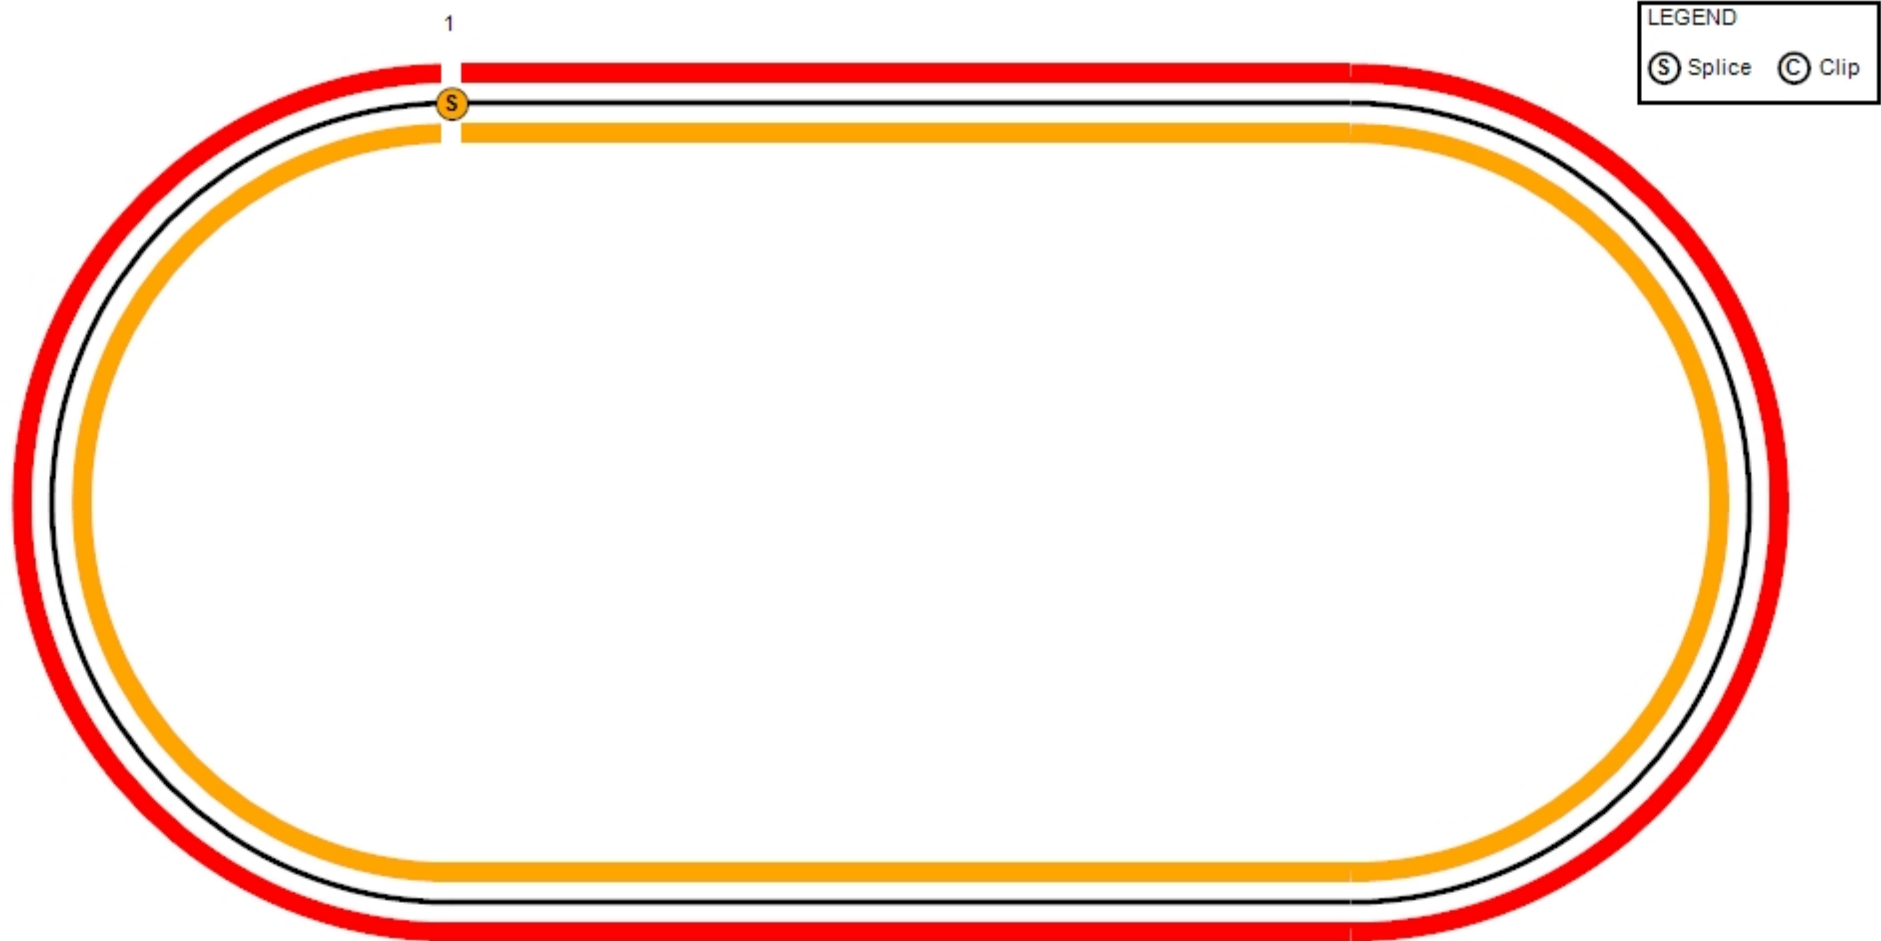
CC204 Conveyor

Conveyor Belt										
#	Joint Detail	Test Date	Comment / Action	Condition	#	Belt Detail	Test Date	Comment / Action	Condition TC	Condition BC
1	Splice	20-01-10	Top cover: Fair condition Bottom cover: Large section removed from splice to carcass 25cm2 and delaminating at edge on RHS. (Belting - Replace) Plan for belt replacement.	Out of Spec	1	IMAS Install: 31-03-10	20-01-10	Top Cover: Poor condition. Section 3m long on LHS edge torn back to carcass, some small gouges on LHS/RHS, also consistent skirt-line damage on LHS. (Belting - Replace) Plan for belt replacement. Bottom Cover: Poor condition. Delaminating between 1st ply from bottom. (Belting - Replace) Plan for belt replacement.	Major Fault	Out of Spec

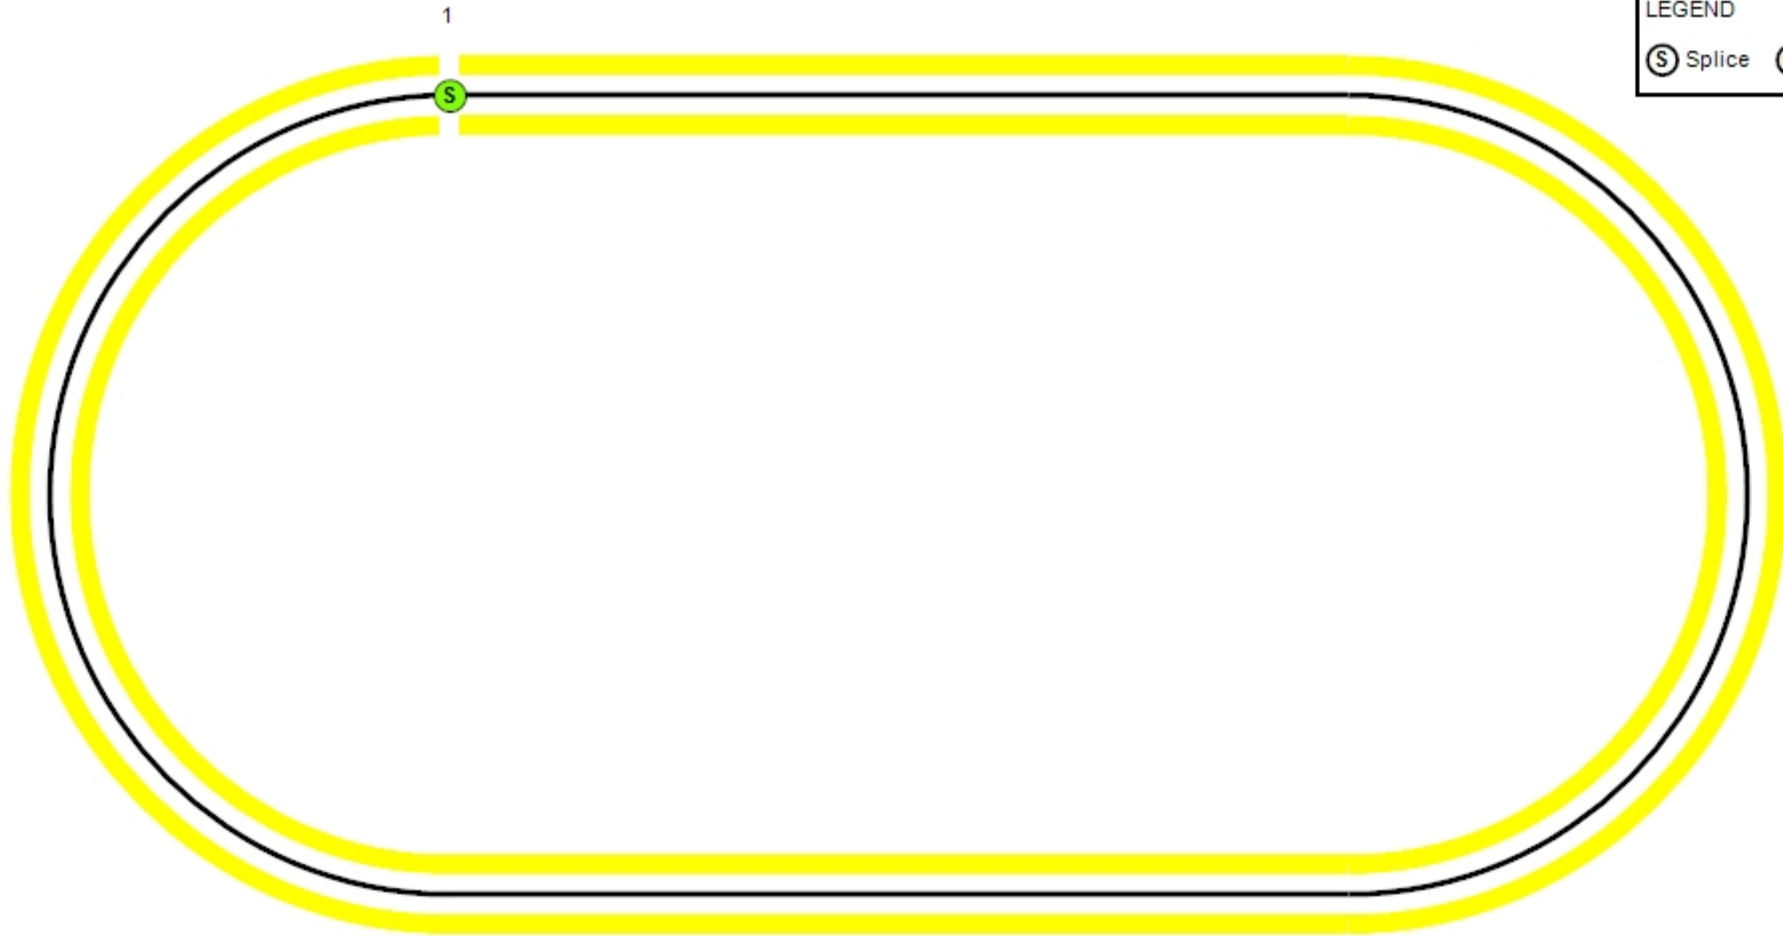
CC205 Coveyor - Belting Details

Conveyor Belt										
#	Joint Detail	Test Date	Comment / Action	Condition	#	Belt Detail	Test Date	Comment / Action	Condition TC	Condition BC
1	Splice	20-01-10	Good condition (Clean/Inspect/Adjust)	Good	1	IMAS Roll: 4300A2 Install: 31-03-10	20-01-10	Top Cover: Fair condition, fraying of edges at RHS, skirt-linewear LHS and delaminating to 1st ply. (Clean/Inspect/Adjust) Monitor for further degradation. Bottom Cover: Fair condition, delaminating to 1st ply edge. (Clean/Inspect/Adjust) Monitor for further degradation.	Fault Minor	Fault Minor
